## *Mazda Service Bulletin*

MAZDASPEED3 (Axela), MAZDASPEED6 (Atenza), and MPS  
Service Bulletin v1.20

11/5/2012

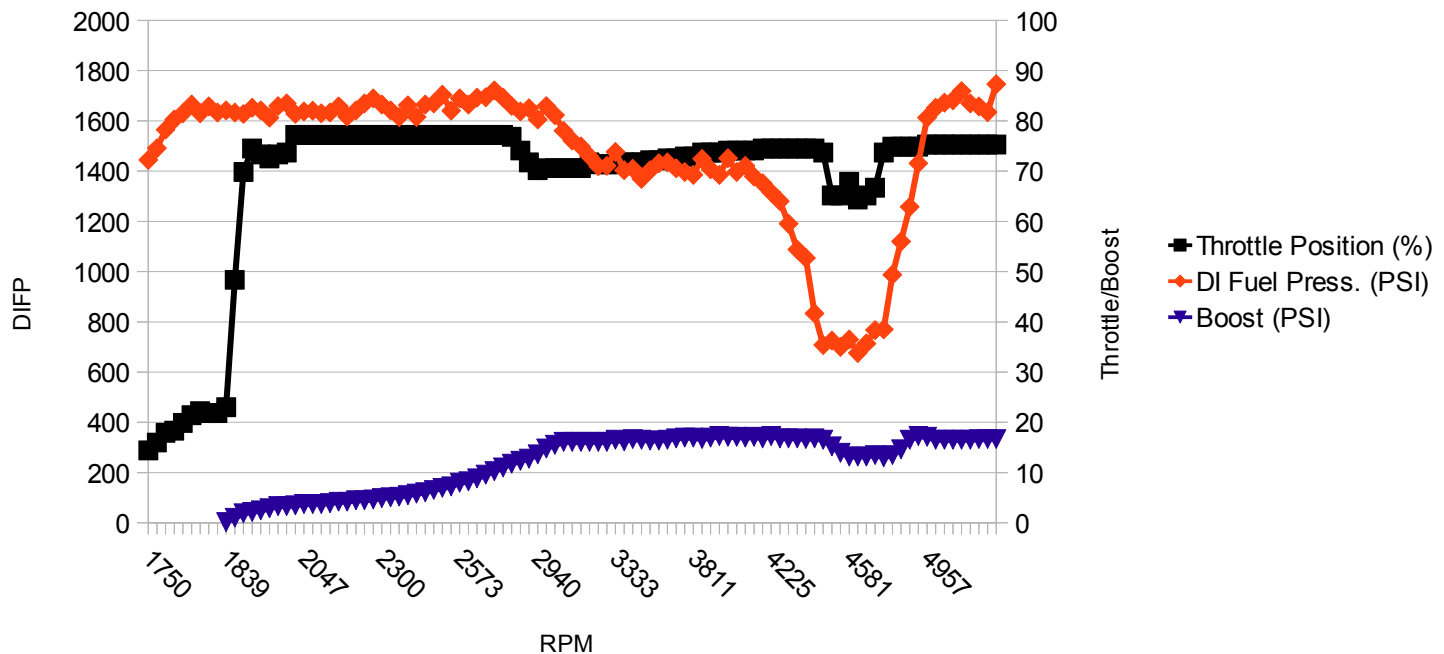
## Stock CDFP Failure

As you can see, the driver is holding the throttle down during a WOT 3<sup>rd</sup> gear run and the DIFP starts dropping off from its target of ~1650psi (at row 47) all the way down to ~700psi. This is an indicator that your current CDFP is not capable of keeping up with fueling demands.

The above graph is from the same datalog. Boost builds and holds steady at around 17psi across the RPM range but, starting at 3000 RPM, the DIFP starts to drop off. It continues to drop off severely enough that the ECU steps in and closes the throttle, lowering boost to help limit torque production and fueling demand. Once boost drops a few psi, the CDFP is capable of building enough pressure to achieve the DIFP targets and the ECU allows the throttle to open fully once again.

Using AccessTUNER Race, you have a two strategies that can be employed (individually or combined) in order to work around this issue until an upgraded CDFP is installed.

- 1) You can incrementally reduce your WOT fueling targets to lower fuel demand. This may not be possible with some lower quality fuels, since it may cause the combustion to be too lean (hot) which can increase Knock Retard values.
- 2) You can incrementally decrease your WOT boost (or load) targets until you have the engine producing less torque, reducing fuel demand.

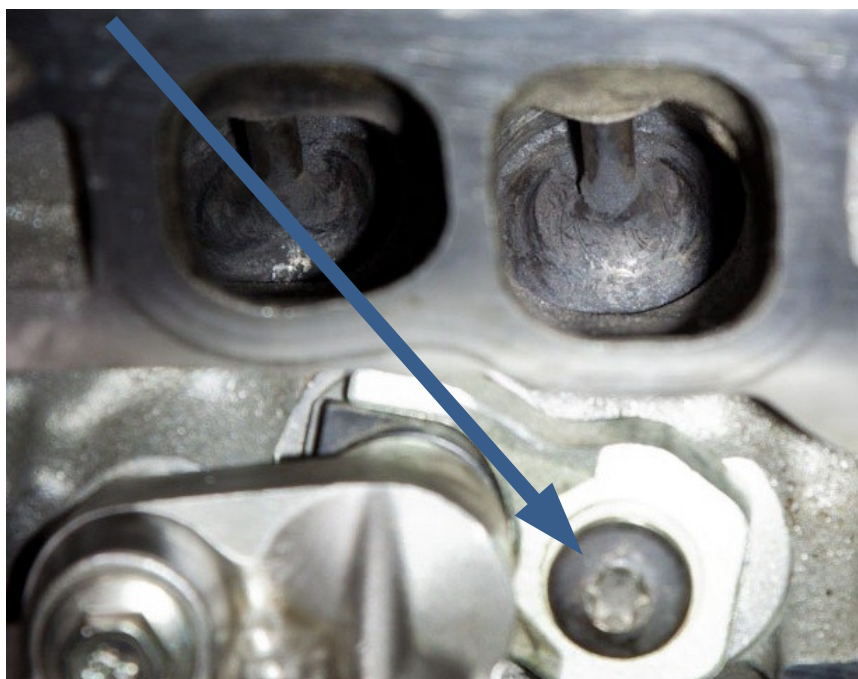
The L3T DISI engine employs direct injection fuel injectors that are mounted in the head and spray fuel directly into the combustion chamber. These injectors are held in place by a bracket and torx bolt (please be careful to not strip this bolt) so they do not pop out under the extreme compression/combustion pressures. Each injector seats against an injector seal located at the bottom of the injector, deep within the head.

With each combustion cycle, these injectors are pushed up or compressed against the bracket and then seat back down on the seals and, with time, the stock injector seals can become compressed allowing the DI fuel injector to rattle within the injector hole. The extreme heat being located so close to the combustion chamber also makes the stock injector seals brittle with time. This rattle is sometimes picked up by the engine's knock sensor and can be calculated as a knock event by the ECU. This is also known as false knock since the knock sensor is essentially a microphone designed to listen for noises

within the frequency range of engine detonation or knock. The engine may not be detonating, but the DI fuel injector rattle can cause false knock which disallows the engine from running properly.

If you notice that your ECU is suddenly picking up more Knock Retard (KR) than normal, and you have ruled out all other common reasons for this (poor quality of fuel from your last fill up, excessive ambient heat, heat soak, rattling heat shield, etc.), then you may need to remove your DI fuel injectors in order to replace the DI injector seals located within the head. One good test for false knock is to fill your fuel tank with 2-4 gallons of higher octane unleaded race fuel, around 100 octane will suffice. If the KR is still present, it's likely that your current DI fuel injector seals are failing or have failed. Several manufacturers offer after market alloy injector seals that are better suited for the higher temperatures and cylinder pressures realized by higher horsepower MAZDASPEEDs. If you plan on generating more than 350WHP or you notice a sudden change in your Knock Retard response, you may need to replace the stock DI injector seals. You can simply type "MAZ-DASPEED injector seals" into your preferred web search engine and several options are available to you.

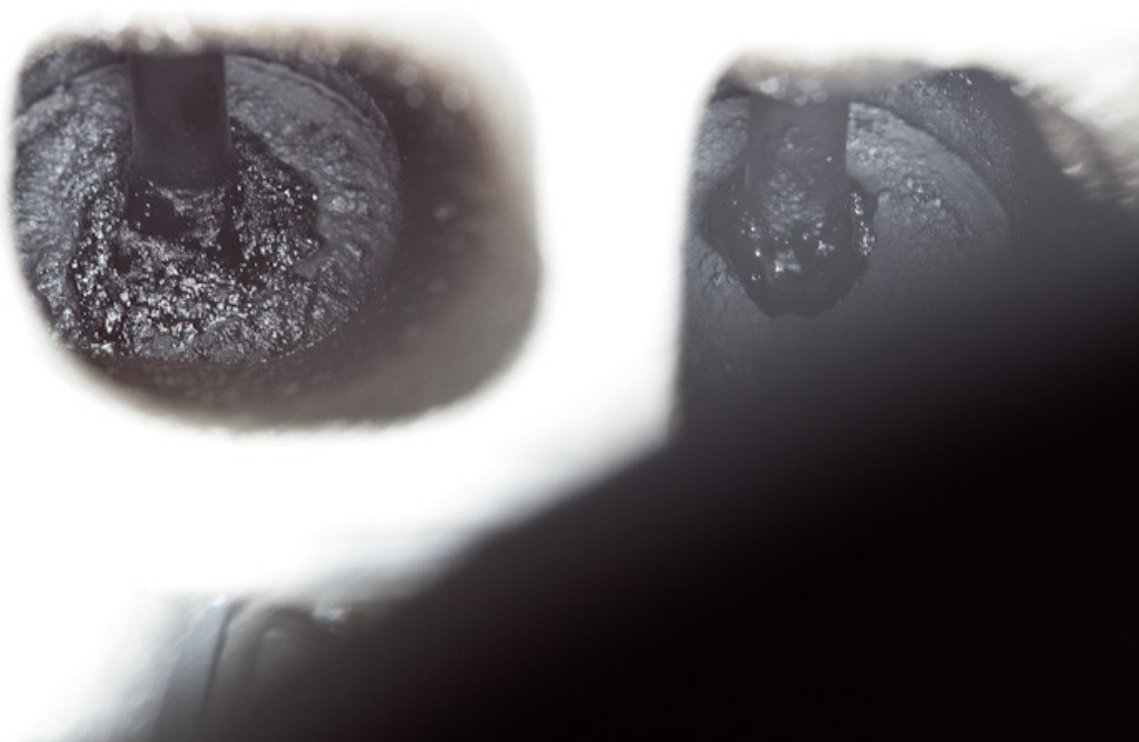
Cylinder #4

These pictures represent cylinder #s 4-2, starting at driver's side of the car and working to the passenger side, where the timing chain is located. Although, as you can see, the intake valves for the cylinder closest to the Exhaust Gas Recirculation (EGR) port, pictured above, have the greatest amount of carbon build up. This carbon build up is more common with

DISI engines since a fuel injector is no longer located in the port, firing above the intake valves in order to help wash the carbon off of the valves. It can be assumed that the valves closest to the EGR system return will suffer the greatest carbon build up.

The valves in this port were the only of the 8 individual ports on the vehicle that showed a thick, gooey type of carbon build up as opposed to a dried/charred looking carbon build up exhibited on the intake valves of the other three cylinders.

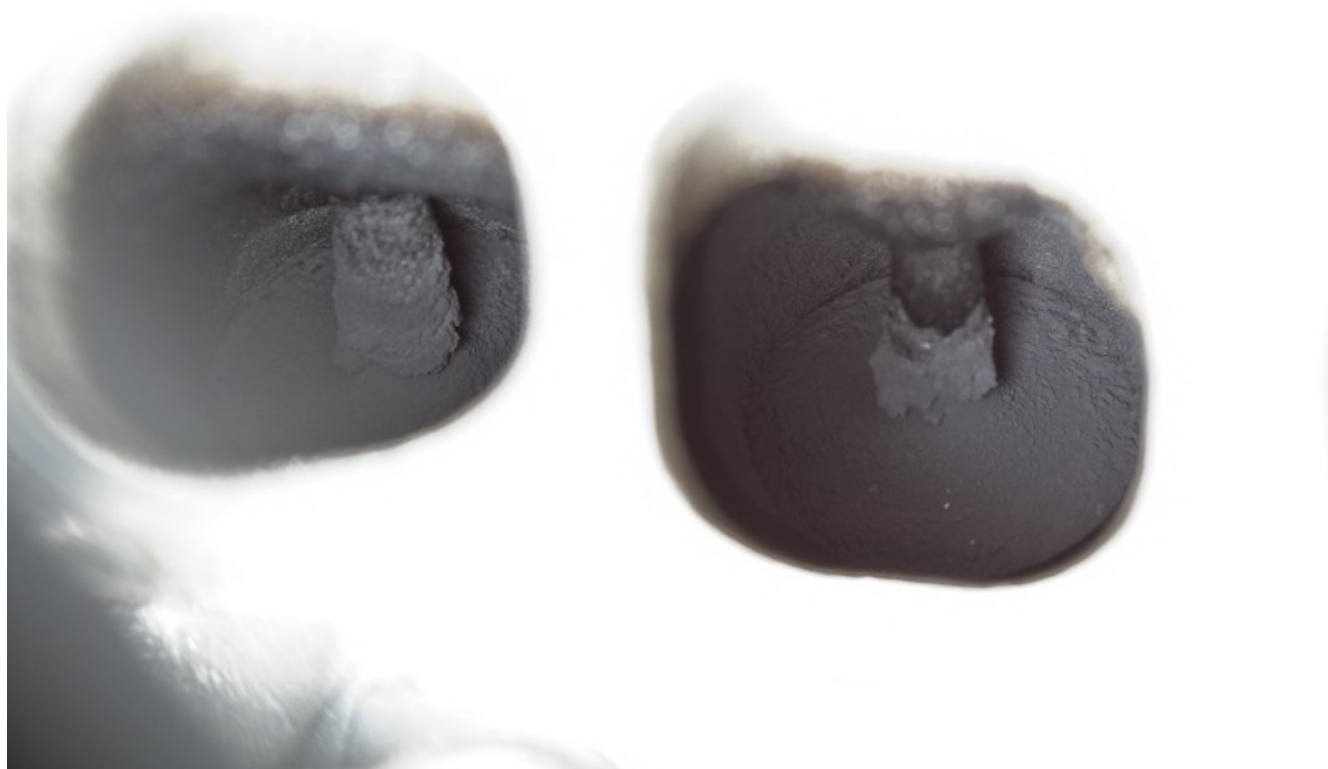
Cylinder #3

Less gooey carbon is present on the intake valves for this cylinder, but the carbon build up is still significant and unexpected for such low mileage.

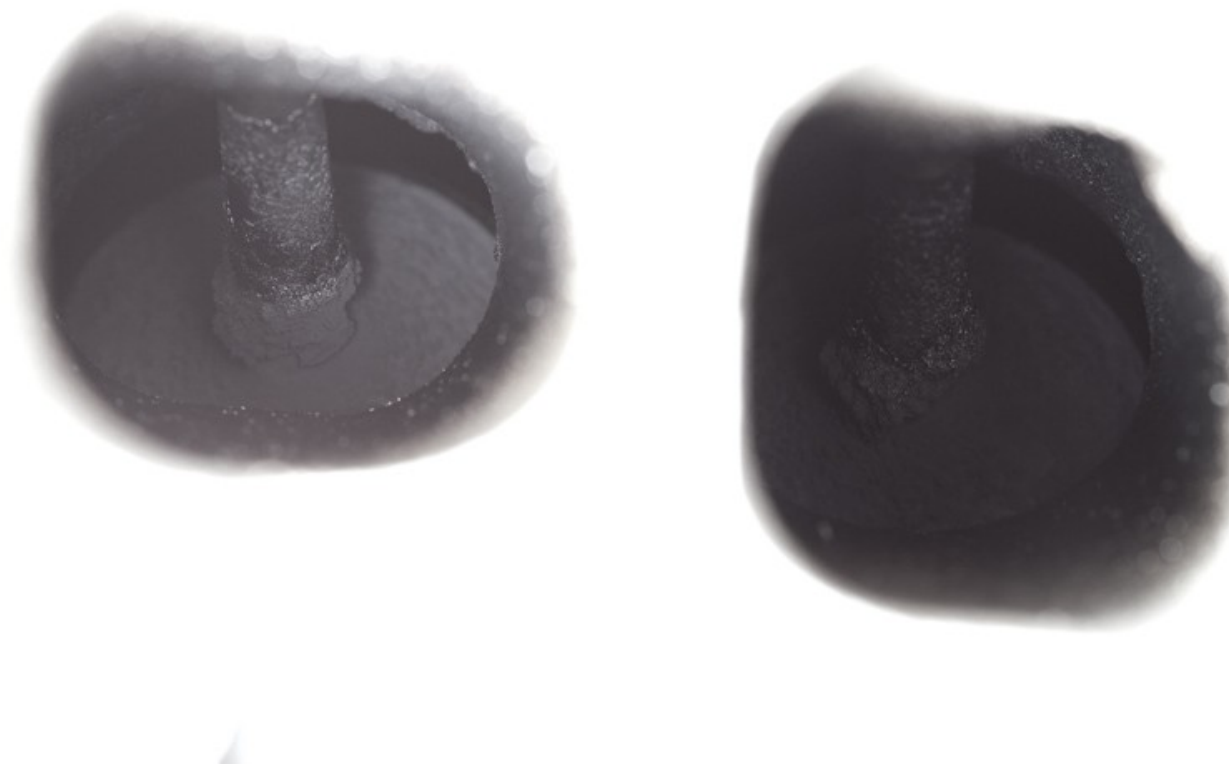
Cylinder #2

Unfortunately, we did not capture a picture of the #1 cylinder before the cleaning. As we mentioned, the carbon build up was less intense on the cylinders that are located farther from the EGR return.

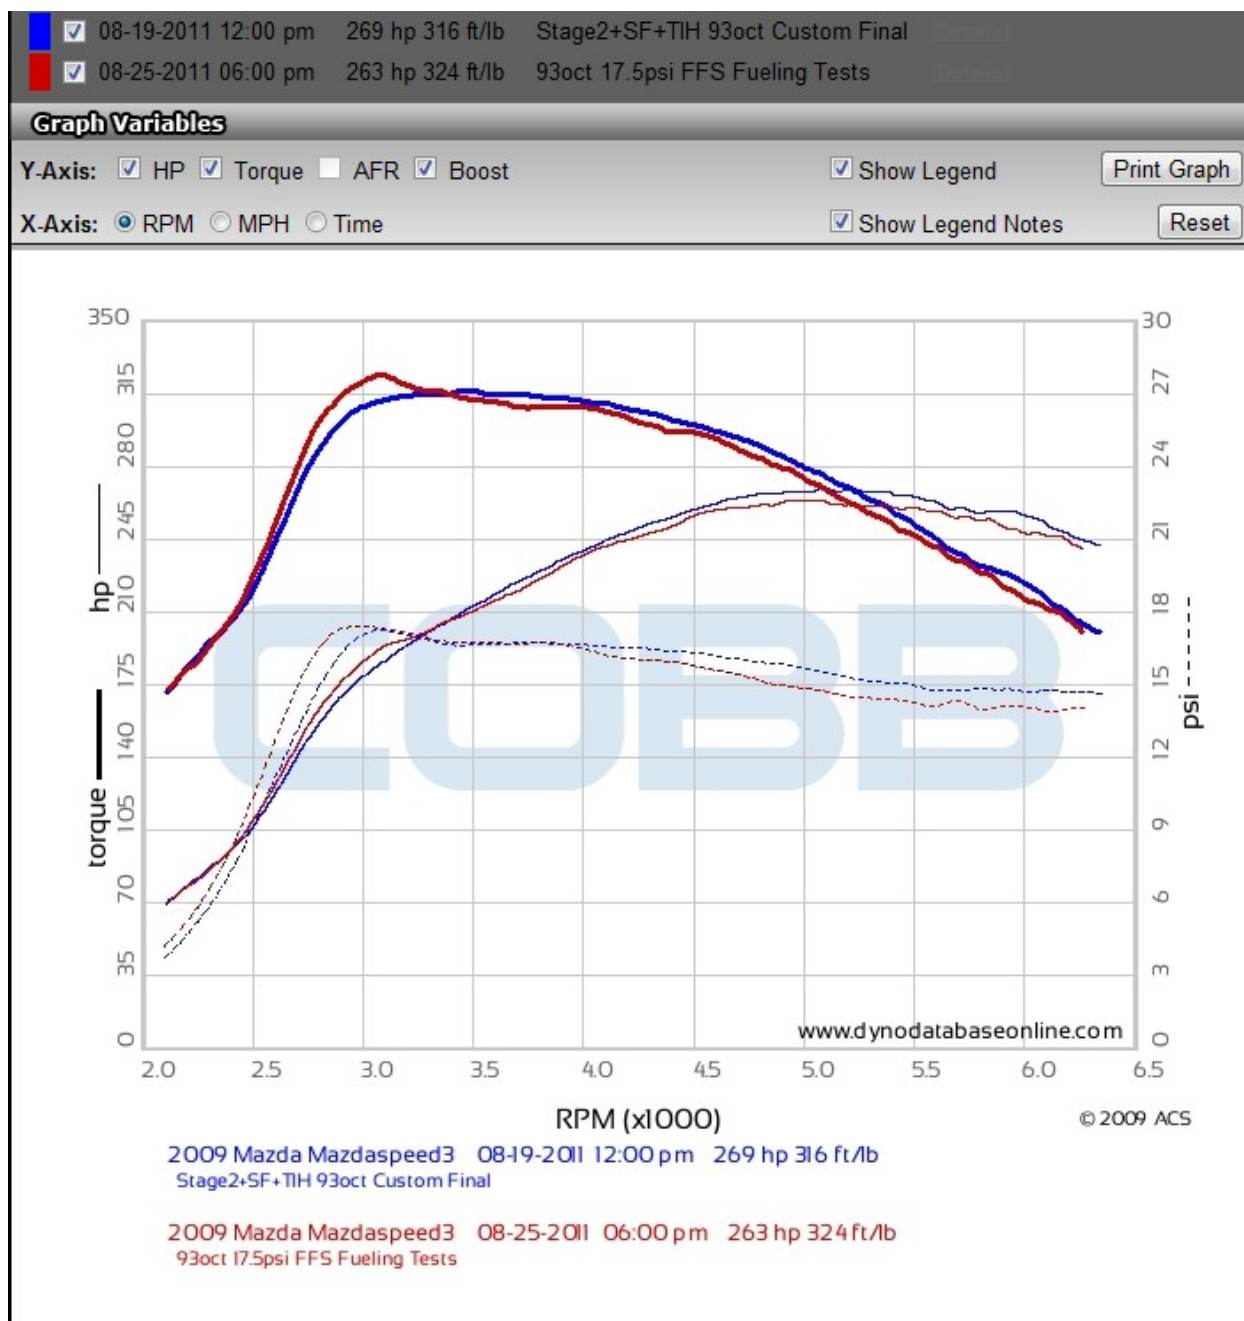
The dyno graph above illustrates a comparison of power production before and after the intake valve cleaning, on the same vehicle with the same calibration. The “before” runs (blue) were done in the morning in approximately 90 degree Fahrenheit temperatures. The “after” run (red) was done in the afternoon with 100+ degree Fahrenheit temperatures.

While the numbers may appear to be inconclusive, you can see that we've gained more peak torque due to the car reaching boost targets at an earlier RPM range. The similarity between power and torque curves is a little misleading, given the significant difference in ambient temperatures and a taper in boost levels above 4000 RPM after the cleaning. The greater flowing intake valves actually run lower boost on the same Wastegate Duty Cycle (WGDC) values. Remember, boost is a measurement of restriction, or how much air is NOT getting into and out of the engine. The carbon build up on the intake valves was effectively decreasing engine airflow and creating more flow restrictions on the intake side of the head.
